**PRELIMINARY ASSESSMENT/
VISUAL SITE INSPECTION**

**ANACONDA-ERICSSON, INC.
SYCAMORE, ILLINOIS
ILD 062 406 608**

FINAL REPORT

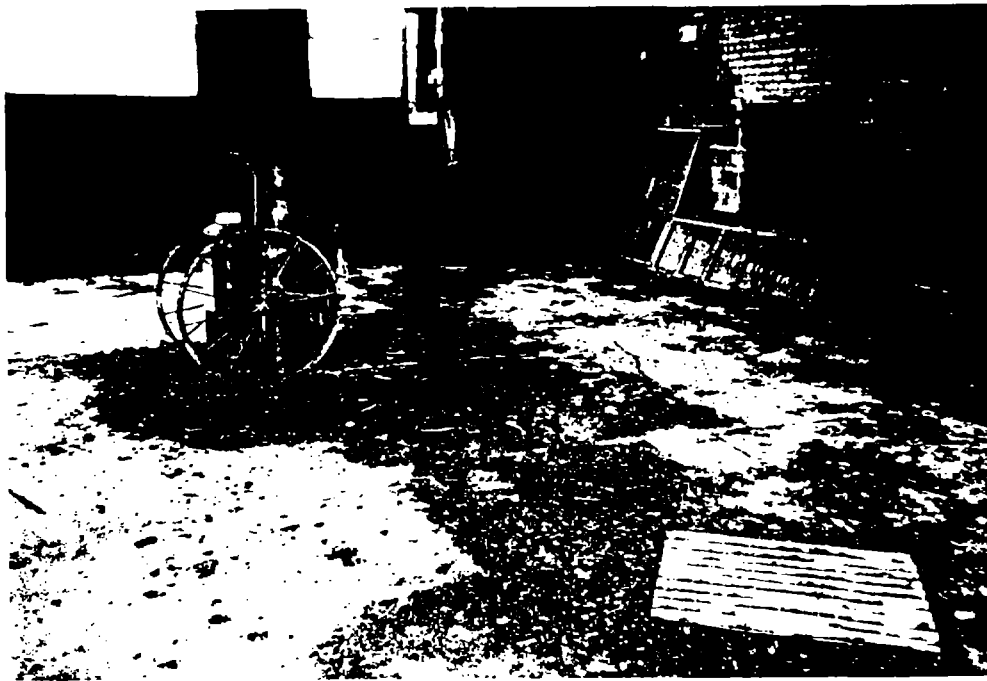
Photograph No. 1

The Hazardous Waste Storage Building was a separate brick building located on the north-central area of the facility. The building was divided into two parts, of which one-half was used for storing general items, such as large wooden spools, and the other half was used entirely for storing hazardous wastes. The dimensions of the building are 42 feet by 42 feet with a concrete floor and a berm dividing the two halves and berms at the door openings. No floor drains were observed in the building. The process design capacity for the unit is 18,750 gallons or 340 55-gallon drums. (see Photographs No. 1 and 2)

The unit is closed. No waste remains in the area. No evidence of release was noted.

Location: SWMU 1

Description: This is the southern half of the Hazardous Waste Storage Building showing the concrete floor (note the bird droppings) and brick walls. Major cracks in the floor are not apparent.

Conclusions: The unit formerly stored 55-gallon drums of hazardous waste prior to RCRA closure in 1983. The unit has a no potential for release to ground water, surface water, air, and on-site soils, as all wastes have been removed, the unit has undergone RCRA closure, and no evidence of release was observed. The past potential for release to the environmental media was low, as waste was managed indoors on a sound concrete floor.

Recommendations: RAI recommends no further action for this unit.

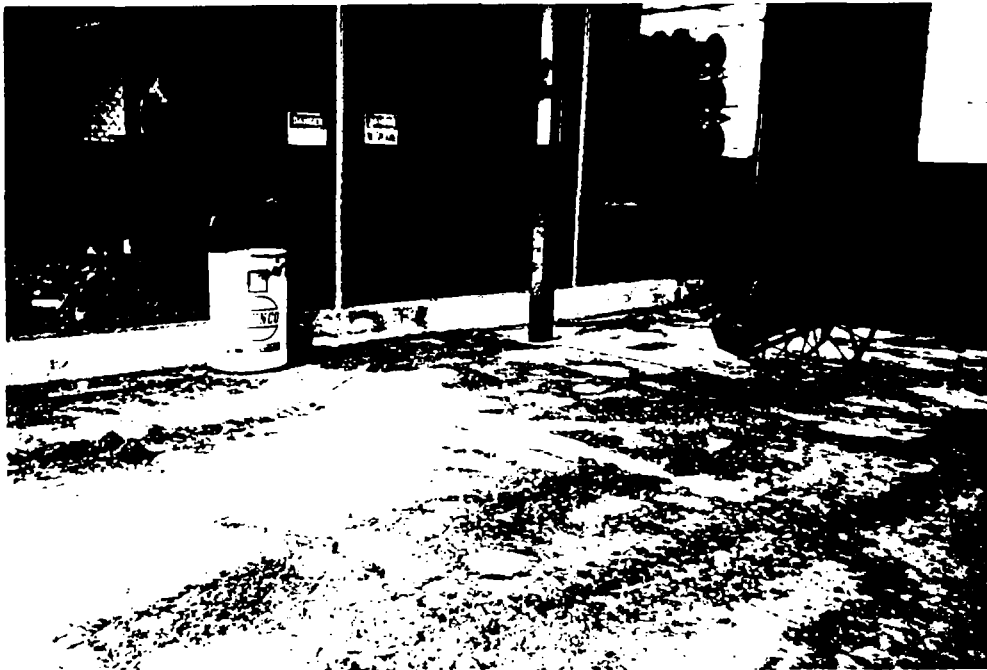
Photograph No. 2

Location: SWMU 1

Description: This is the northeastern section of the area used for storage of hazardous waste in drums showing the concrete floor and the berm which divides the building into two parts. Major floor cracks are not apparent.

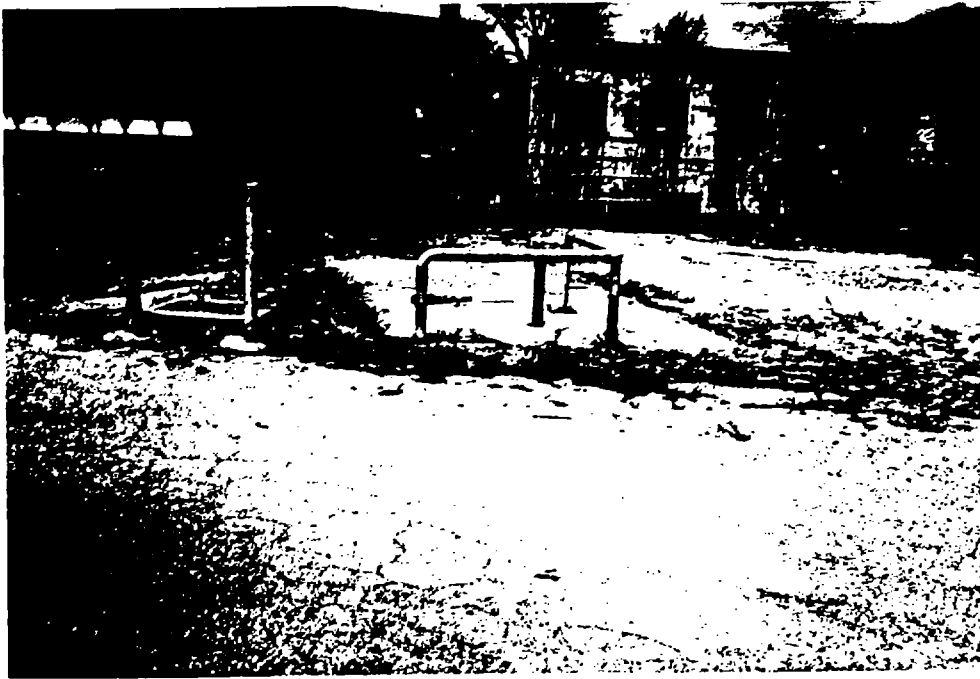
Photograph No. 3

Ground Water and On-Site Soils: Moderate to high. There is no evidence of any testing, past or present, hence the tanks could be leaking. Any release would contaminate on-site soils and could affect the ground water.

Location: AOC 1

Description: Location of diesel fuel UST with a 9-foot by 18-foot concrete pad at the ground surface. View also shows the location of the former pump used for fueling trucks.

RAI recommends that, under proper authority, tank testing or soil sampling be conducted.

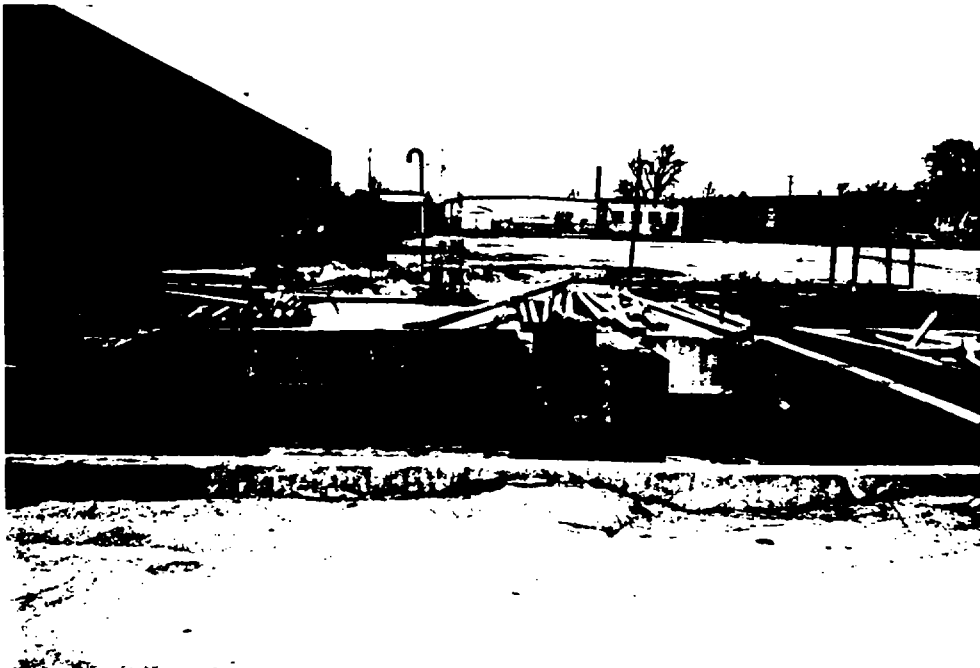
Photograph No. 4

Location: AOC 1

Description: Six fuel oil USTs with 25-foot by 25-foot concrete containment area, located in the north central area of the facility.

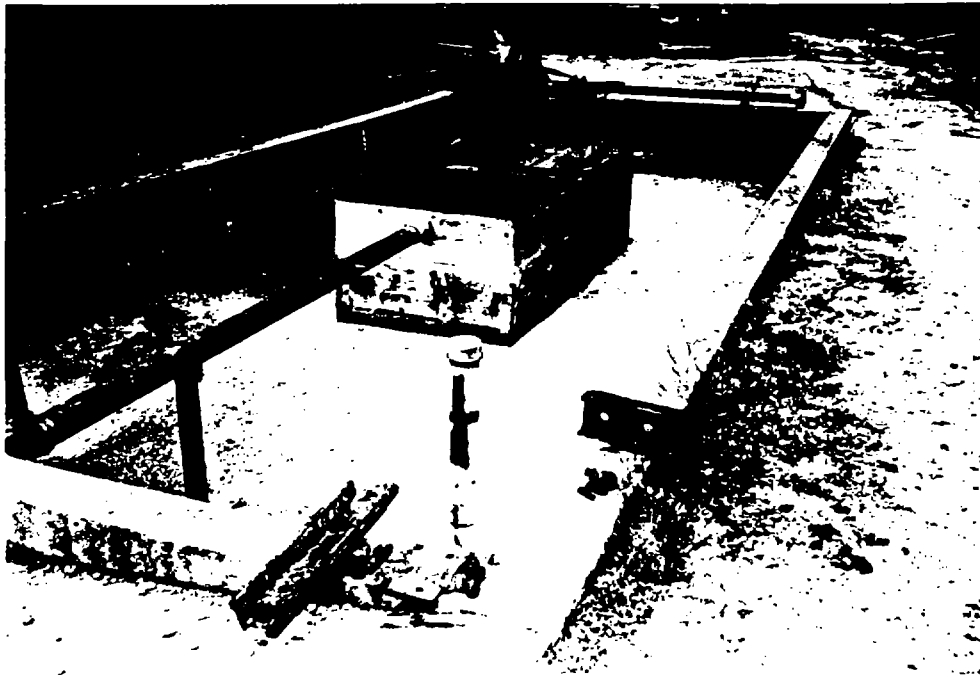
Photograph No. 5

Location: AOC 1
